Thermal Control Surfaces Experiment

D.R. Wilkes
AZ Technology, Inc., Huntsville, Alabama

Prepared for Marshall Space Flight Center
under Contract NAS8-38939

January 1999

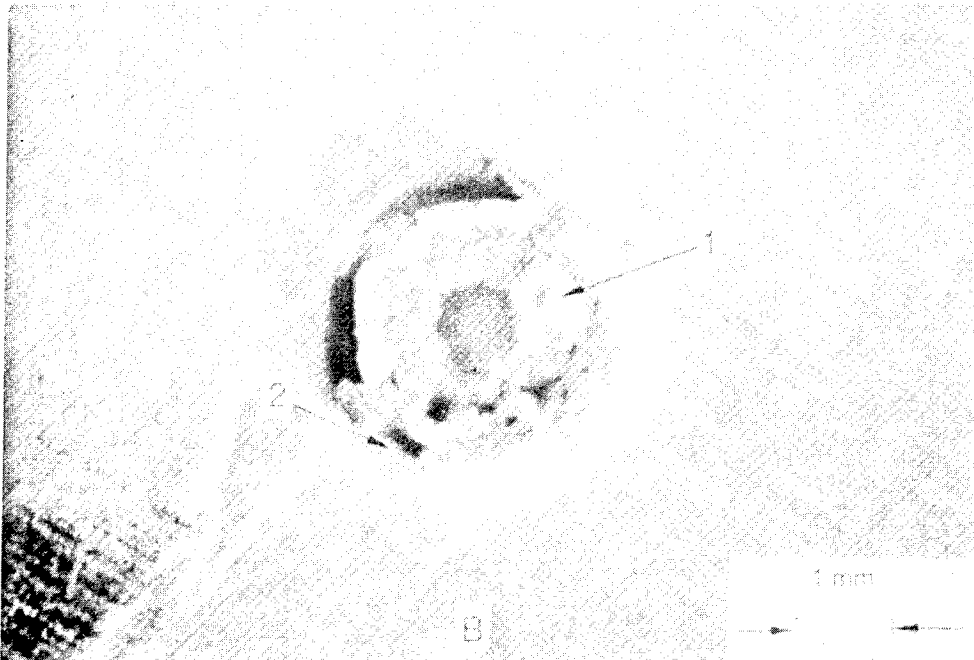
Rear View

Figure 17. Impact Penetration of Front Panel.
(Panel: 6061AL; 0.063 MIL Thickness)

One penetration occurred on the TCSE front cover. The M&D published report states, "The largest documented feature was a 2.5mm diameter impact in the silver Teflon cover. This impact delaminated a considerable amount of the Teflon blanket and exposed the silver backing to oxygen erosion." Figure 17A provides a close-up view of the impact showing the crater and silver Teflon layer "blown" back from the crater rim. At location "1" of Figure 17A, the Teflon layer has radial cracks emanating from the crater impact center. Some of the silver/inconel layer is still attached to the Teflon. For the silver Teflon closest to the impact area, the silver/inconel and adhesive layers are missing. The exit of the impact event is shown in Figure 17B, with the small region indicated at area "1".
